1 Summary

This mission was performed by The Johns Hopkins University Applied Physics Laboratory (APL) to develop and fly a balloon-borne gondola with a scientific payload for the observation of Comet ISON and other planetary objects, during a one-day flight demonstration in September 2013. APL performed this task under the direction and sponsorship of the Glenn Research Center (GRC). Specifically, APL defined, developed, delivered, and operated the Balloon Rapid Response for ISON (BRRISON) gondola that would perform a first demonstration flight to make scientific observations of the Comet C2012 S1 (ISON). ISON is a sun-grazing comet that may have freshly emerged from the Oort Cloud on its first, and likely its only, pass through the inner solar system. The balloon-borne platform was designed to make ground-breaking observations to directly address key science questions posed by the planetary decadal survey, “Vision and Voyages for Planetary Science 2013-2022.” APL developed a gondola that used flight heritage from the Stratospheric TeraHertz Observatory (STO) balloon mission, which has already demonstrated capabilities important to a planetary science balloon platform, while at th

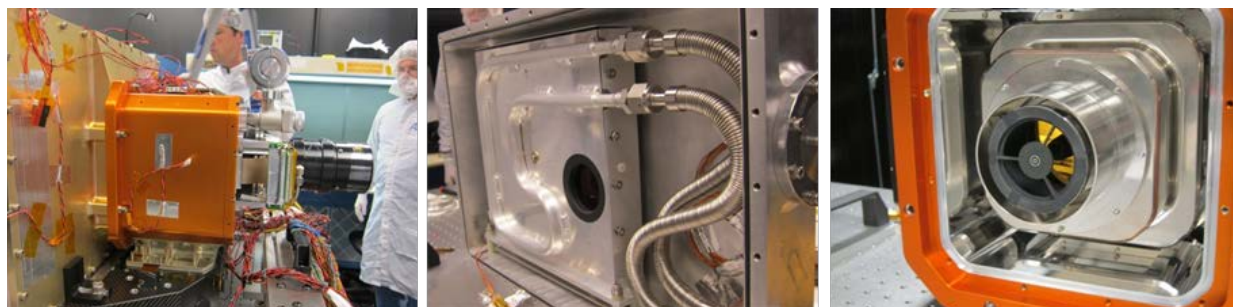
Figure 4. (left panel) the IR camera (orange) and cryocooler (black); (center) the cryogenic filter wheel housing with LN₂ cooling loop; (right) the mini-RC telescope within the IR camera.

The BIRC thermal design was divided into multiple zones. The camera focal plane was operated at approximately 70 K, within a structure (“inner sanctum”) to which the mini-RC telescope was mounted, all of which was cooled by the cryocooler; the mini-RC was operated at approximately 80 K. The filter wheel mechanism was within the same vacuum enclosure as the camera inner sanctum, but was separately cooled with liquid nitrogen; the filter wheel was operated at approximately 125 K. A separate enclosure, also cooled by liquid nitrogen, was mounted on the BIRC optical bench and contained the three fold mirrors and the collimating asphere of the relay optics; this cold enclosure was separated from the camera and filter wheel vacuum system by a CaF₂ window. The relay optics in the cold enclosure operated at approximately 190 K. Another CaF₂ window was located at the entrance to the cold enclosure on the IR optical bench, where light from the main telescope was passed into BIRC. The optical bench and the main telescope were operated at or above ambient temperatures. Two 50 liter cryogenic dewars were located on the gondola base structure. The dewars contain over 80 kg of LN₂ for cooling the filter wheel and optical bench elements. Insulated copper tubing and a vacuum-jacketed flexline across the telescope gimbal carry the LN₂ from the dewars to the IR payload. The filter wheel assembly and the mini-RC are shown in **Figure 4**.

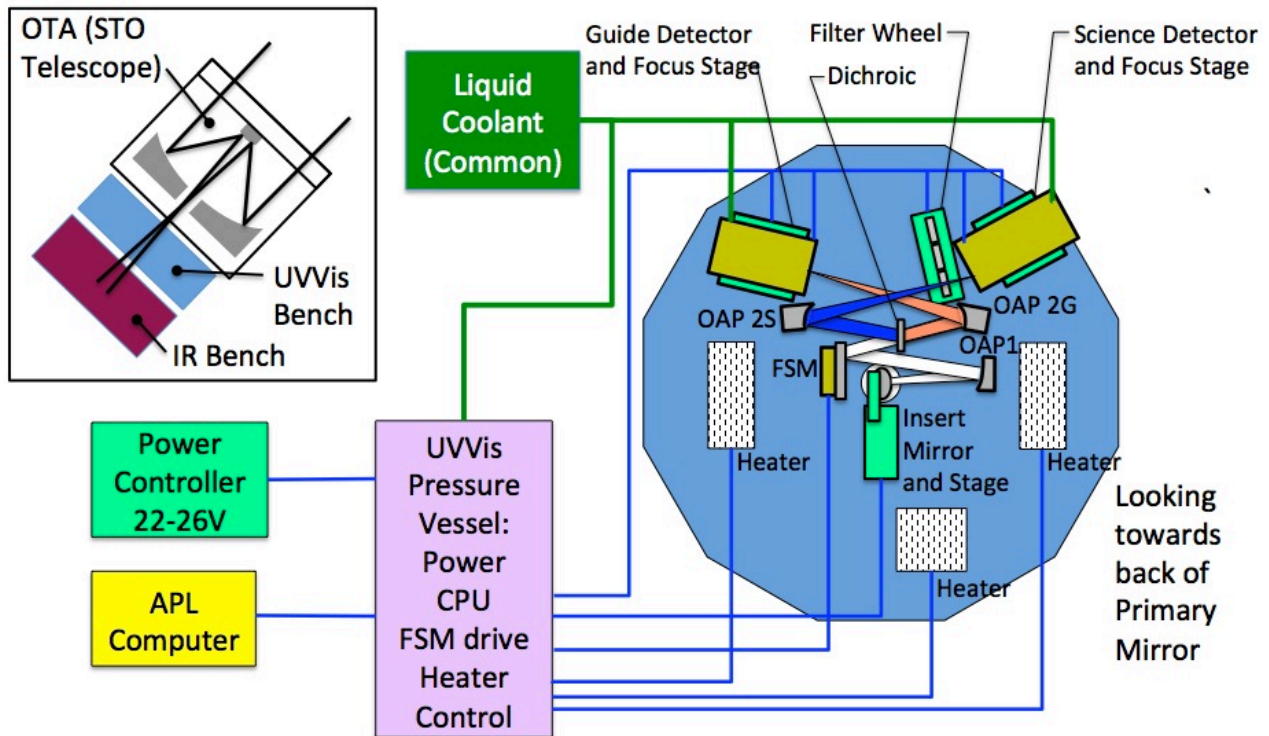
Figure 7 UVVis Block Diagram

The UVVis optical bench consists of two cameras (a Guide Camera and a Science Camera), two actuators (a fold mirror and a filter wheel), a fine steering mirror (FSM), and various optical elements (three off-axis paraboloids, a dichroic and baffles). The two cameras and two motors are housed in separate pressure vessels. The UVVis electronics are housed in a large pressure vessel (PV) located about 1 m away from the UVVis optical bench. The UVVis PV contains three main elements: the FSM controller board, the CPU (a consumer i7 processor and motherboard with six 500 MB SSDs), the electronics power supply (EPS), consisting of boards that supply power to the FSM, the CPU, the cameras, the actuators and some heaters on the UVVis bench. The UVVis optical bench is a 1-m hexagon made of two carbon fiber face sheets separated by 4-in of aluminum honeycomb. The UVVis optical bench is enclosed in Dupont “Styrofoam” to help provide an isolated and stable thermal environment. A block diagram of the UVVis Payload is shown in **Figure 7**. **Figure 8** displays the UVVis as attached to the BRRISON telescope cradle.

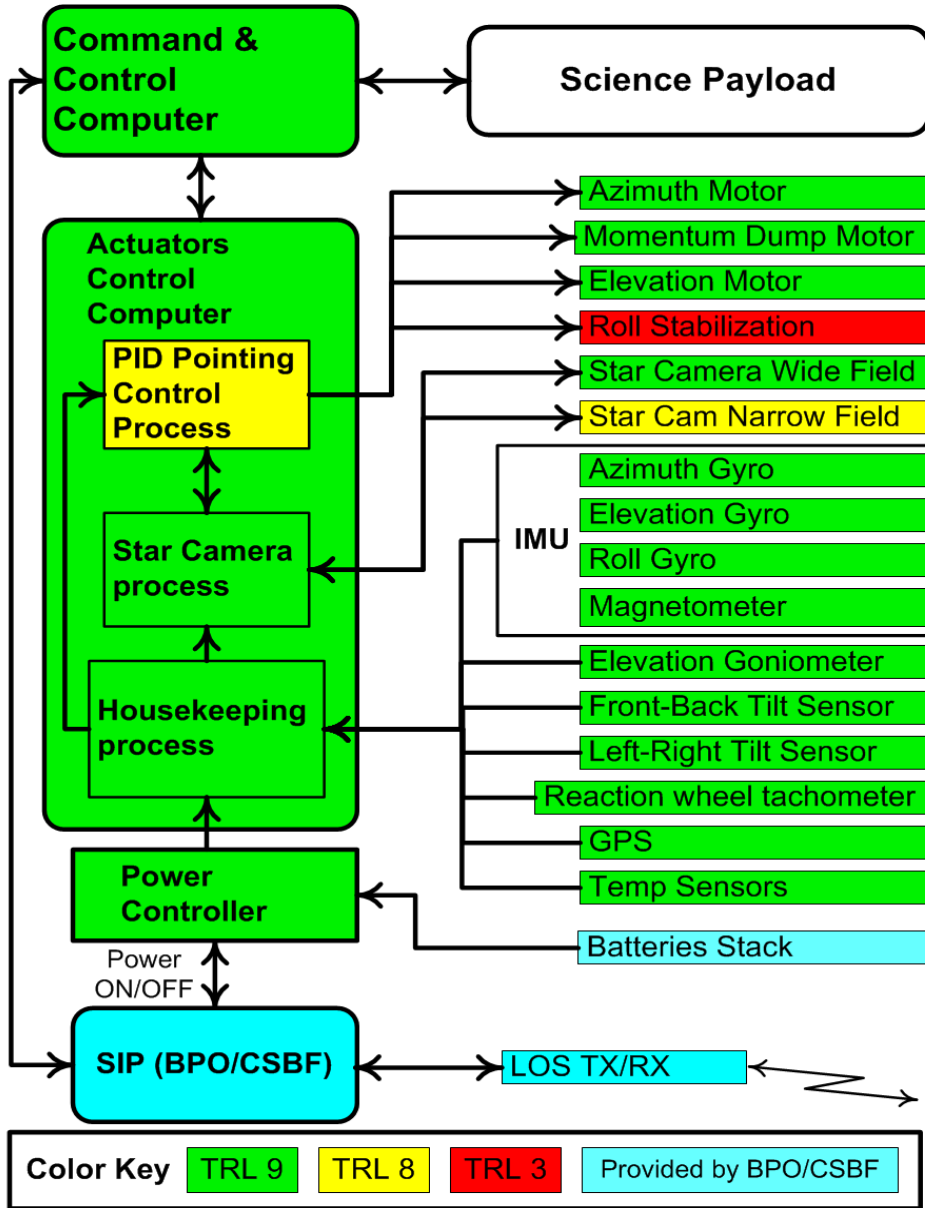
Figure 9 This BRRISON block diagram shows use of high heritage as a result of reuse of equipment from STO and prior missions.

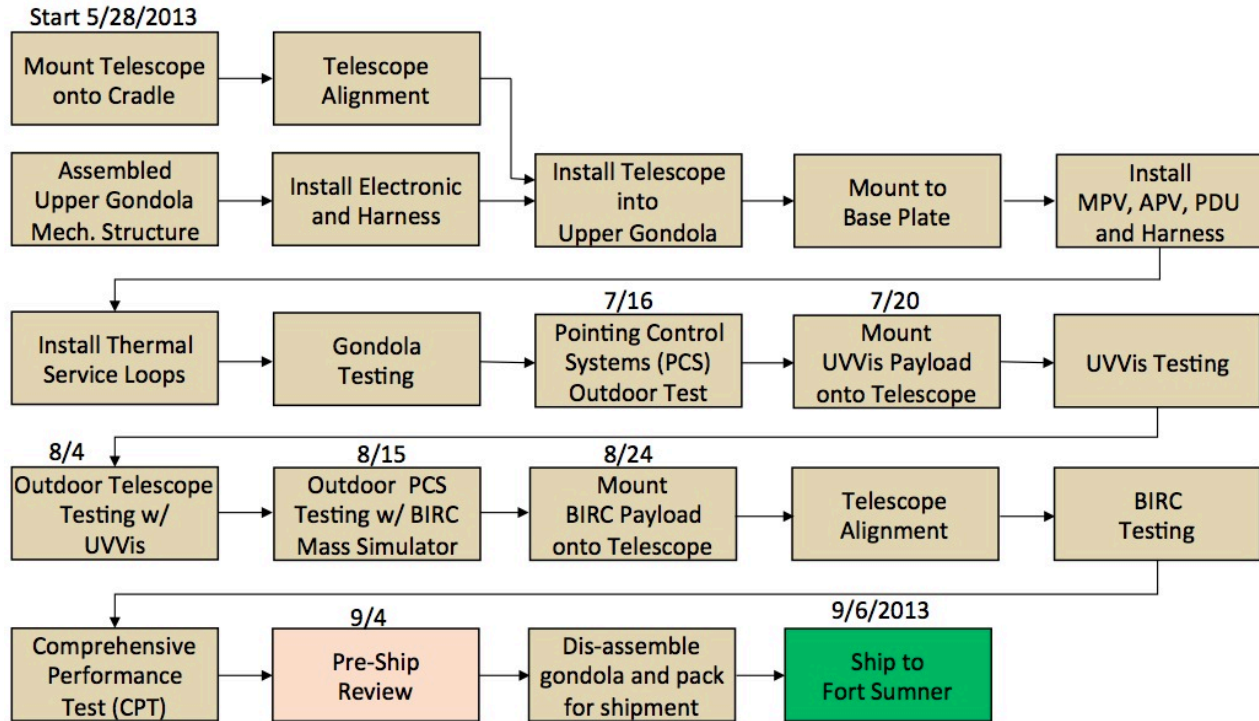
Figure 10 APL Gondola I&T Flow

Figure 10 gives an overview of the actual I&T flow at APL.

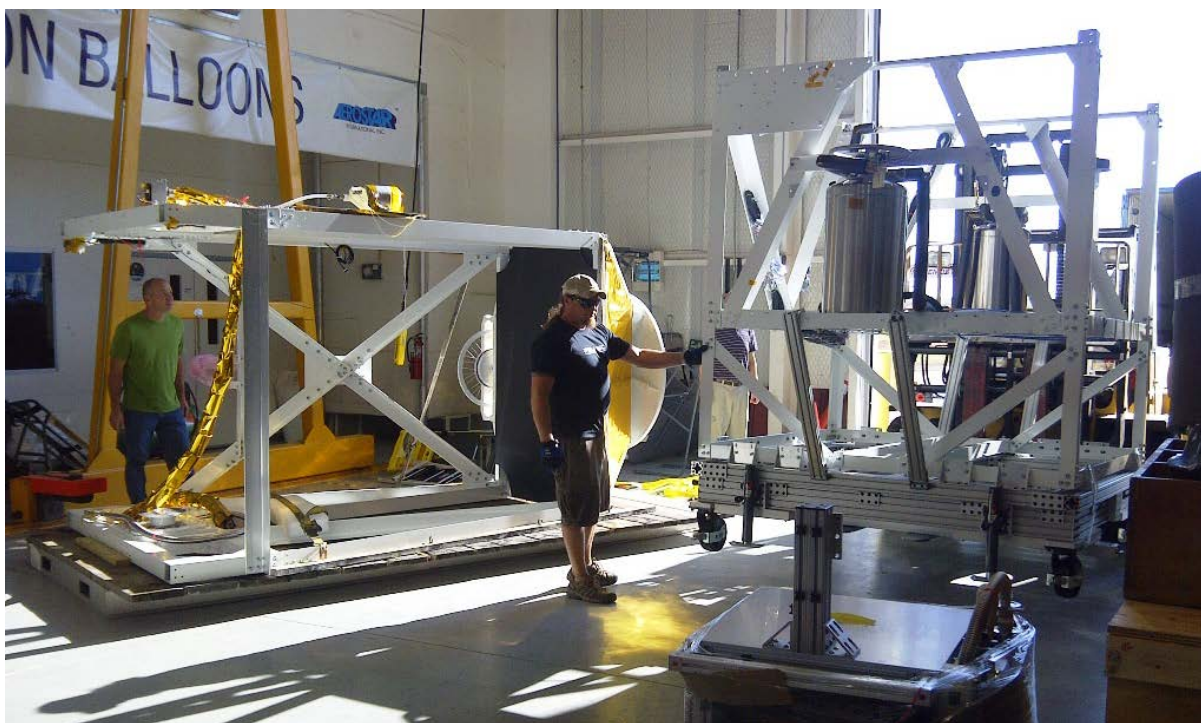
Figure 12 BRRISON gondola arrives in Fort Sumner in sections

Monday, September 9: Gondola, payload, and supporting GSE equipment was delivered to the NASA/CSBF balloon I&T facility via truck (**Figure 12**). After the equipment was unloaded and inspected set-up of the work area as well as the MOC and SOC stations took place.

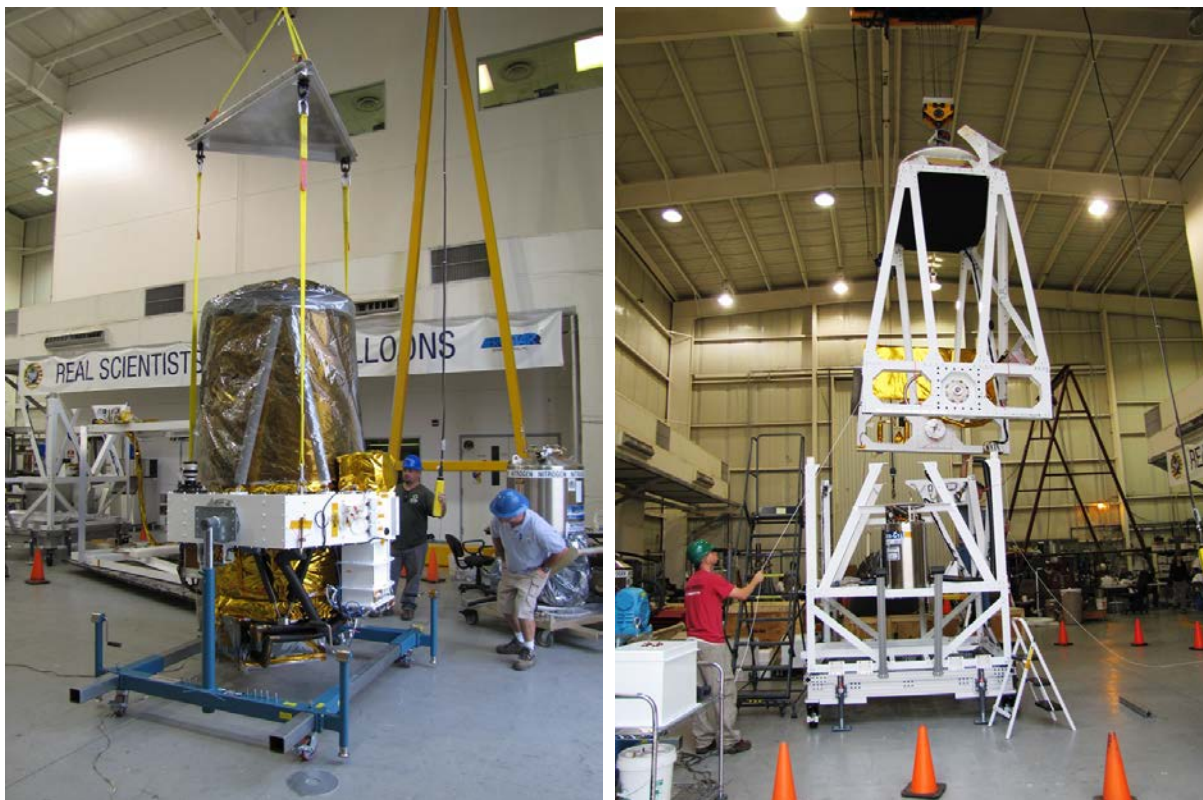
Figure 13 (Left) Installation of the telescope/instruments assembly on the Flotron. (Right) Gondola upper structure is installed on top of gondola baseplate.

Tuesday, September 10: Transfer of the payload from the shipping fixture to the Flotron test fixture occurred (**Figure 13 - Left**). This was followed by the setup of payload alignment and calibration optical system. Then the gondola upper structure was mated to the gondola baseplate and the gondola flight computers were installed on the baseplate (**Figure 13 - Right**).

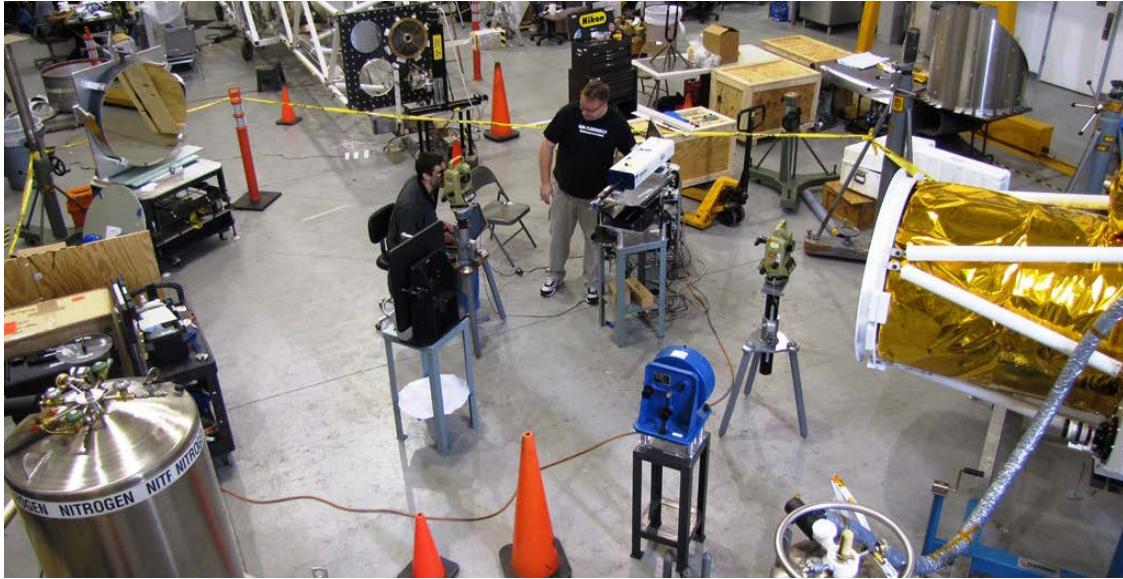
Figure 14 APL optical engineers performing BIRC alignment calibrations.

Friday, September 13: The BIRC instrument geometric calibrations were completed and focus sweeps were performed. The pointing offset between BIRC and UVVis were measured (**Figure 14**). Activities for calibrating the UVVis instrument continued. The installation of the Mini-SIP inside the SIP cage at the bottom of the gondola was completed (**Figure 15**).

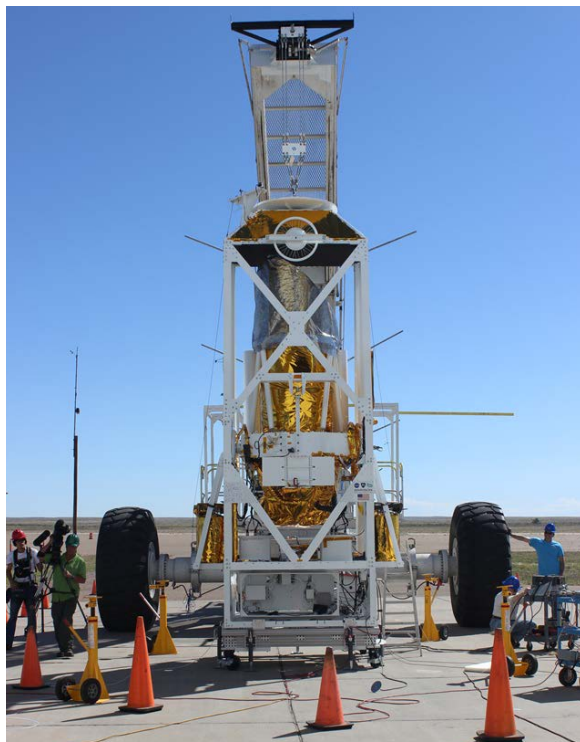
Figure 17 Gondola suspended outdoors from the launch vehicle during the compatibility test.

perform all functions and to communicate, i.e. uplink commands and downlink telemetry as if in flight (**Figure 17**). All tests were fully successful.

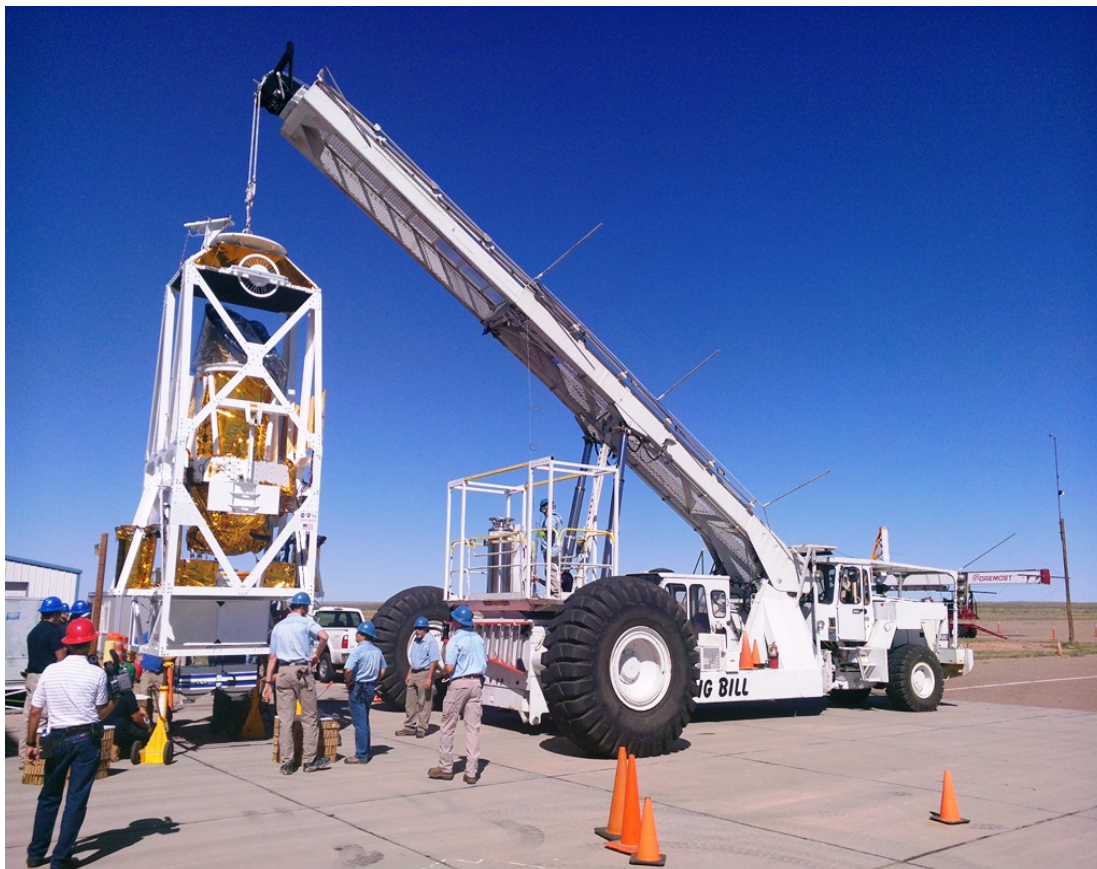
Figure 18 BRRISON gondola suspended from launch vehicle being readied for launch.

At 1:30 pm the launch vehicle “Big Bill” arrived to pick-up the gondola and moved it outside. CSBF personnel installed the ballast hoppers and crush pads (**Figure 18**). The LN2 purge line and GSE power supply were transferred from ground to Big Bill. Meanwhile health of the gondola and payload systems was constantly monitored

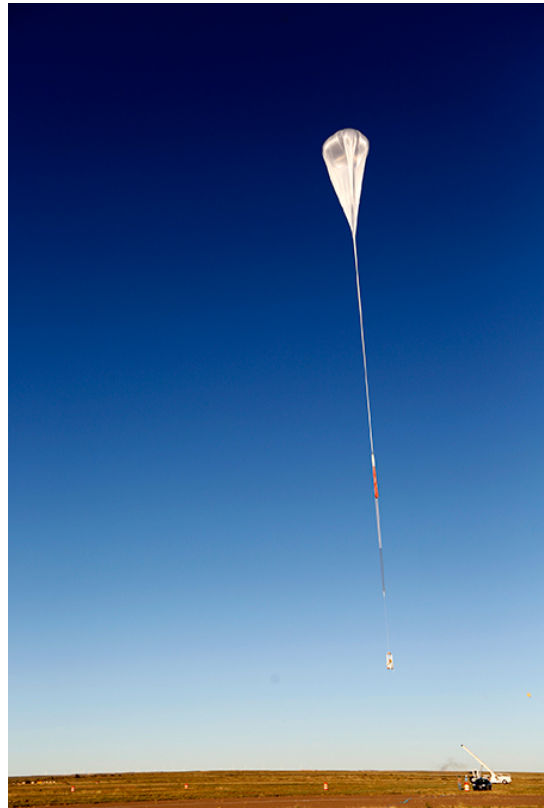
Figure 19 The BRRISON gondola starts ascending.

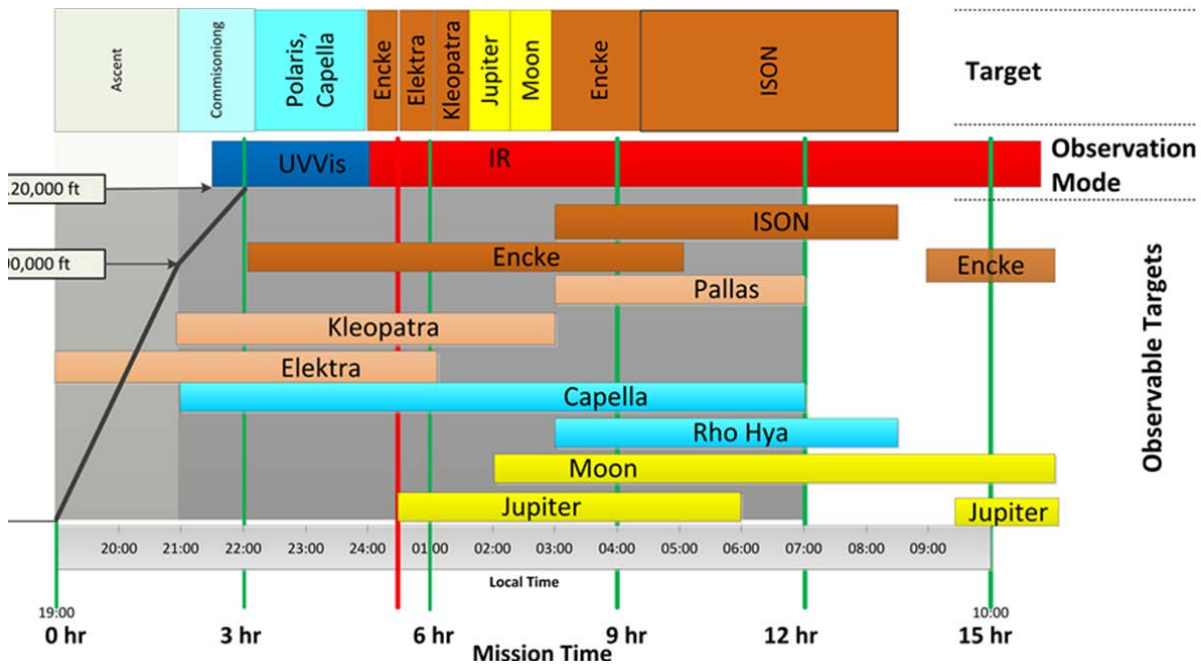
Figure 20 Planned flight timeline based on a target launch time at 7pm local time.

The planned flight timeline is shown in **Figure 20**. This timeline is vastly different from what was originally planned because of the drastic change in the time of launch. The original target launch time on any given day was 7 am, but the new actual launch time was 6 pm implying a different schedule for the observing targets. In the original timeline the first target would have been the comet ISON itself, but with the new launch time ISON could not be observed until it rose at about 4:15 am local time. So it was planned to first observe other targets and also to start observations with the UVVis instrument instead of with the IR instrument. The targets planned before observing ISON and the sequence of observations is listed on the top part of **Figure 20**.

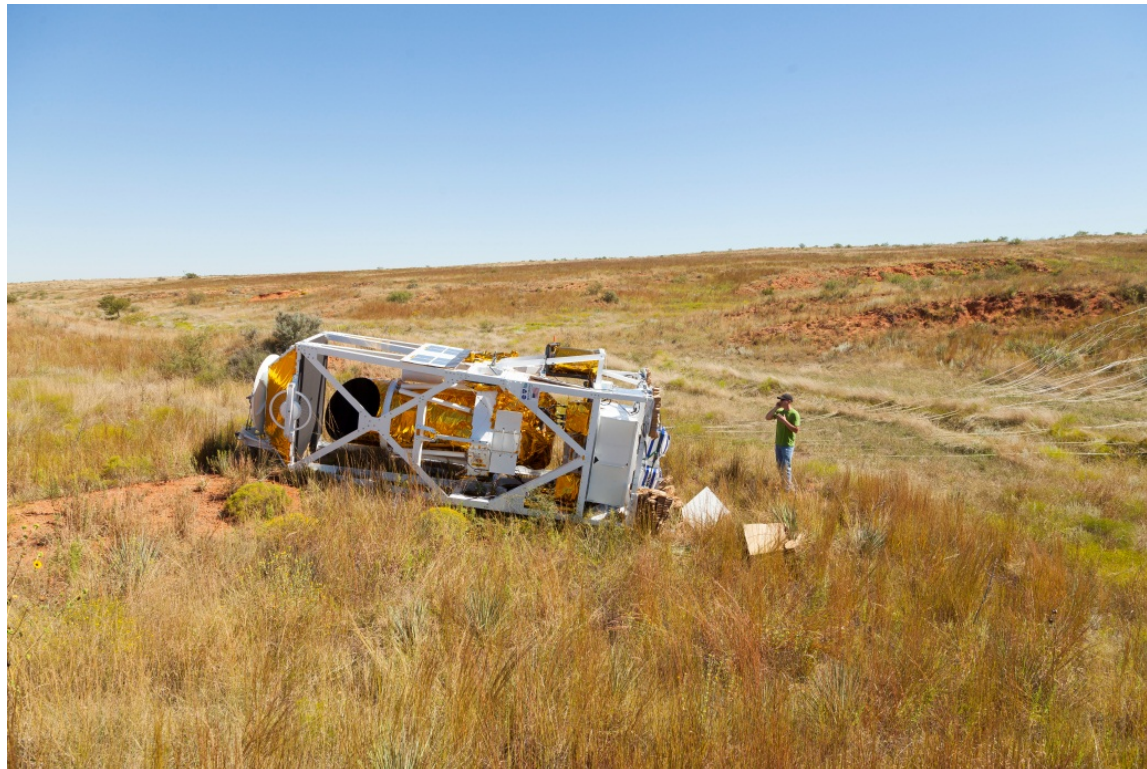
Figure 21 BRRISON Gondola seen as landed approximately 55 miles east of Lubbock, Texas.

The gondola landed in a shallow ravine on a large ranch near Guthrie, Texas. The recovery team was given two strict instructions: to thoroughly photograph the untouched gondola and its surroundings; and focus on preserving any evidence that would assist in assessing the anomaly by limiting the disturbance of the gondola. An image of the gondola as it was found at the landing site is shown in **Figure 21**.
